Section: 01	Date: 2017-10-23	Job ID: 1234-5678	Client: MINICAM	Operator: M.STARK
-----------------------	----------------------------	-----------------------------	---------------------------	-----------------------------

Place: GOLBORNE	Direction: Upstream	Start Ref: 0401
Road: MARYFIELD CLOSE	Use: Combined	Start Depth: 1.12m
	Pipe Shape: Circular	End Ref: 9402
	Pipe Material: Concrete	End Depth: 1.09m
	Width / Height: 300mm

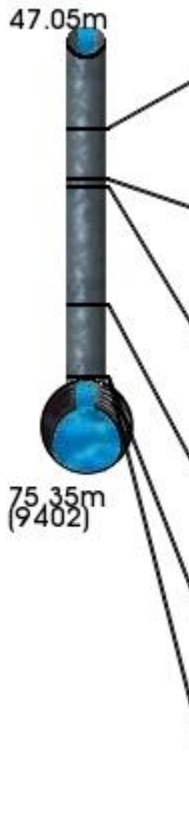
Meterage	CD	Code	Observation	Video	Pic.
64.38m		JNX	JNX: Junction Not defective 100 mm. At 10 O'Clock	00:07:31	
66.66m		ECX	ECX: Encrustation Light. from 12 O'Clock to 5 O'Clock	00:07:59	(2)
66.96m		JNX	JNX: Junction Not defective 100 mm. At 2 O'Clock	00:08:15	
72.23m	S1	ECX	ECX: Encrustation Light. from 5 O'Clock to 7 O'Clock S1	00:09:06	(3)
75.35m	F1	ECX	ECX: Encrustation Light. from 5 O'Clock to 7 O'Clock S1	00:10:08	
75.35m		ENX	ENX: End of survey.	00:10:11
